AFRL-RZ-WP-TR-2010-2186

**PROPULSION AND POWER RAPID RESPONSE
RESEARCH AND DEVELOPMENT (R&D) SUPPORT
Task Order 0011: JP-8+100 Development History and Maintenance
Benefits**

**JUNE 2010
Interim Report**

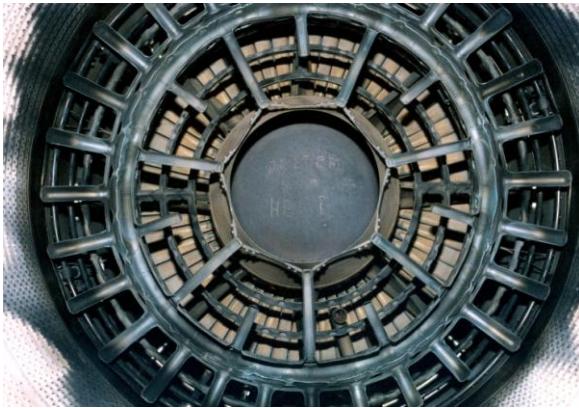
**Figure 1. F100-PW-200 Engine Showing
Turbine and Augmentor After
200+ Hours on JP-8**

For over a decade, **Figures 1** and **2** have been used in many publications and presentations to show vivid examples of a 'dirty engine' using JP-8 versus a 'clean engine' that had been using JP-8+100. To a seasoned engine maintainer, an immediate benefit of a clean engine is the ability to quickly accomplish a visual inspection of the hot section parts such as the fuel nozzles, turbine vanes and blades, and the after burner and exhaust system components. Any finite cracks and/or worn parts are no longer covered by carbon and coke deposits and thus easily detected during the scheduled inspection. **Figures 3** and **4** show similar pictures of the afterburner section for General Electric (GE) F110 engines.

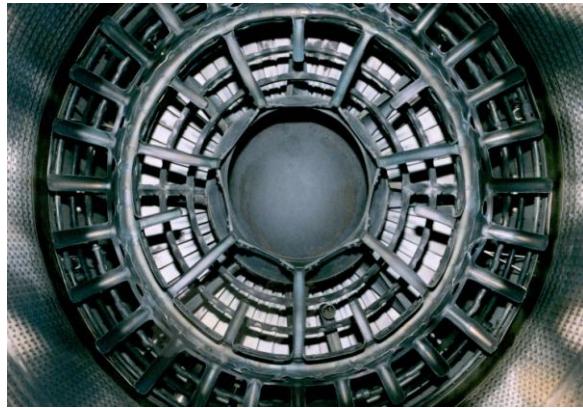
**Figure 2. F100-PW-200 Engine Showing
Turbine and Augmentor After
56 Hours on JP-8+100**

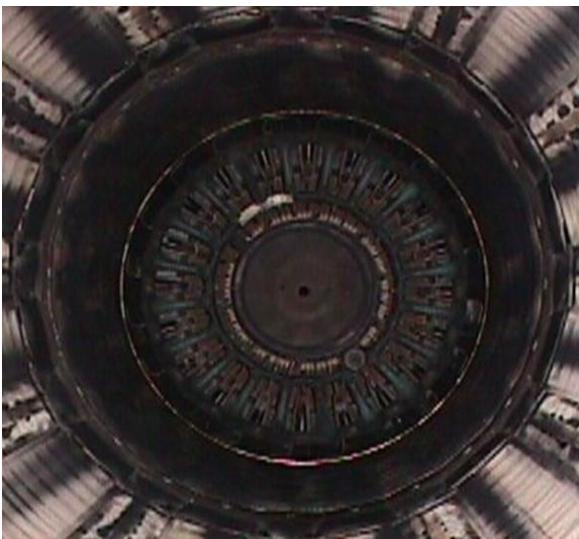
**Figure 3. F110-GE-100 Engine Showing
Turbine and Afterburner on JP-8**

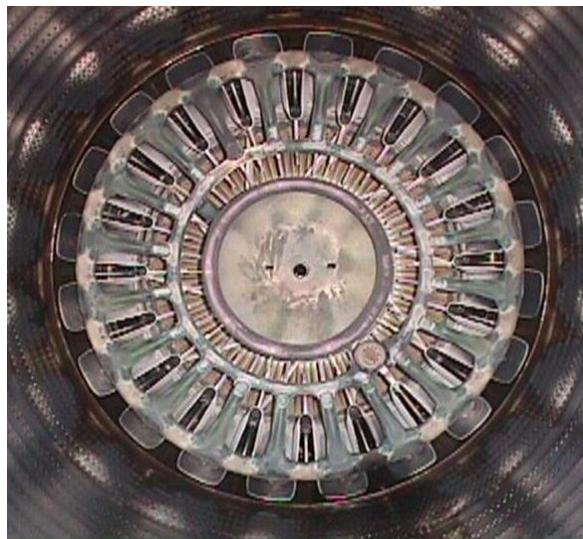
**Figure 4. F110-GE-100 Engine Showing
Turbine and Afterburner on JP-8+100**

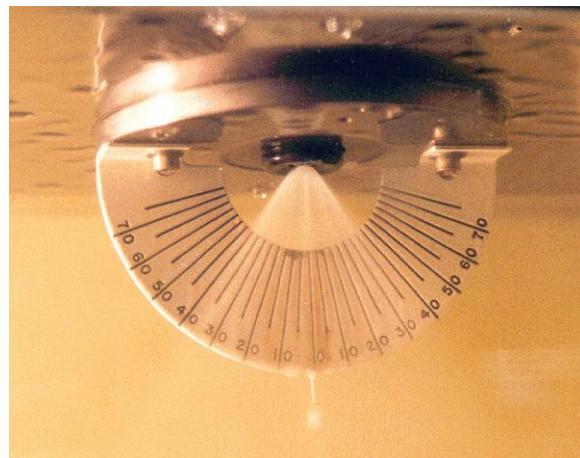
Figure 7. Spray Pattern Streaking From Coke Deposits on Nozzle Tip

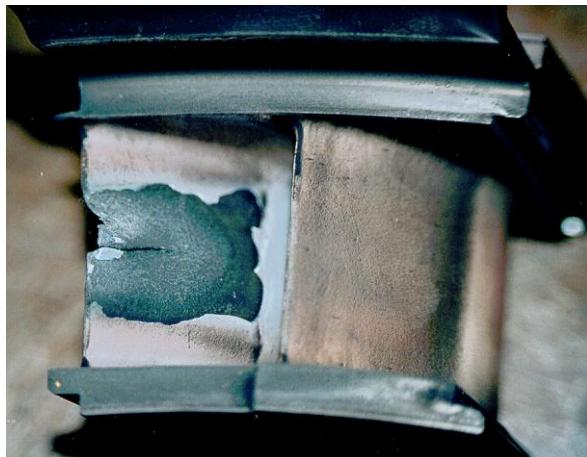
Figure 8. Turbine Vane Damage Resulting From Streaking Fuel Nozzles

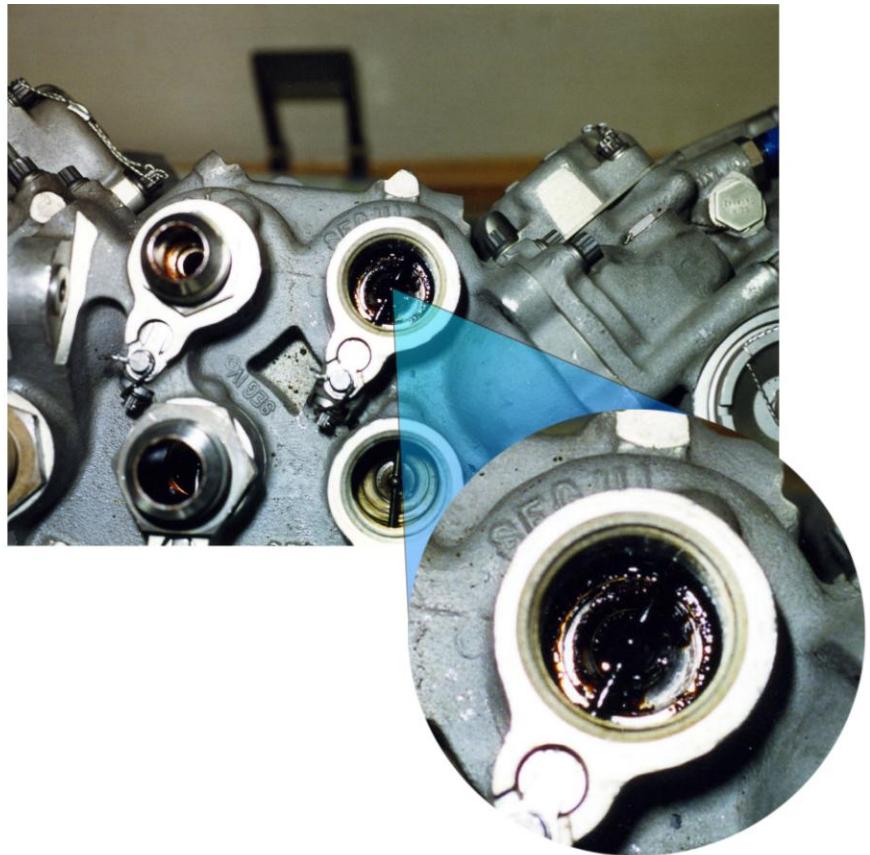
outlet ports starting with 7 in CY98, 15 in CY99, 53 in CY00 and 85 in CY01. **Figure 15** shows the coke slurry that has accumulated in the Seg III fuel outlet port of an AFC from a -220/E engine. The inner parts of the regulator valve shown in **Figure 16** have been removed from the Seg III valve regulator port shown in **Figure 17** for cleaning. Note the coke particles and gums on the valve parts and in the side port of the Seg III housing that can affect valve operation. The cleaning and reassembly is accomplished without removing the fuel manifold housing.

Figure 15. Coke in AFC SEG III Fuel Outlet Port

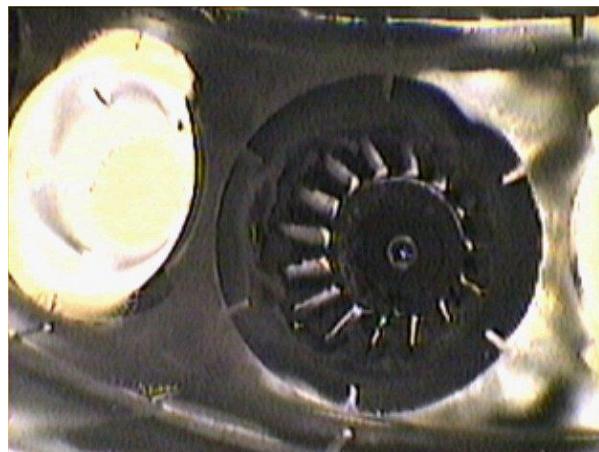
**Figure 30. T64 Combustor Dome,
EOT: 857 FH; +100 Time: 815 FH**

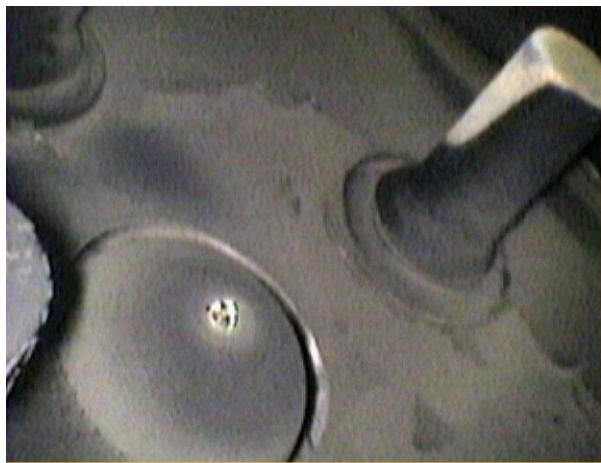
Borescope inspections were performed on four heater combustors before the operational evaluation started and at the end of the first heating season. The flight crews were also asked to estimate heater use during each flight and enter the time on the aircraft forms which were tallied periodically. After 100 to 200 hours of operation using JP-8+100, the combustor cans remained relatively free of carbon and coke deposits with only small deposits in remote sections of the combustor. Borescope images for the baseline condition and after 179 hours of operation were compared. In all cases, the fuel nozzle and combustor remained clean in each heater with the exception of a light shiny varnish on the nozzle tips that did not affect the operation of the combustor. (See **Figures 39 through 42**)

Figure 39. MH-53 Heater Combustor Dome, +100 Time: 0 Hrs

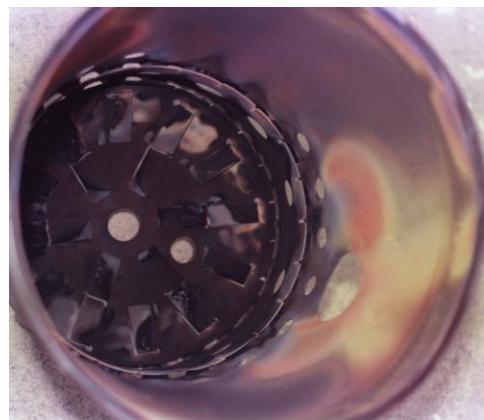
Significant coke and soot deposits were observed in the dome of each combustor, especially around the igniter as well as on the face of the fuel spray nozzle. **Figures 81 through 84** show typical coke deposits in the combustor dome, chunks of attached carbon, coking on the face of the fuel spray nozzle and coke crystals on the lip of the primary shroud. **Figures 85 through 88** show the carbon deposits on the wall of the combustor, the dome, combustor exit vanes and the igniter area although the carbon deposits were considered typical for this engine type. As the coke crystals grow in size and carbon deposits increase around the secondary shroud, it is possible that the fuel spray pattern will begin to streak fuel causing localized distress on the combustor exit vanes.

Figure 81. Coke Deposition in Combustor Dome, 250 C20B Engine

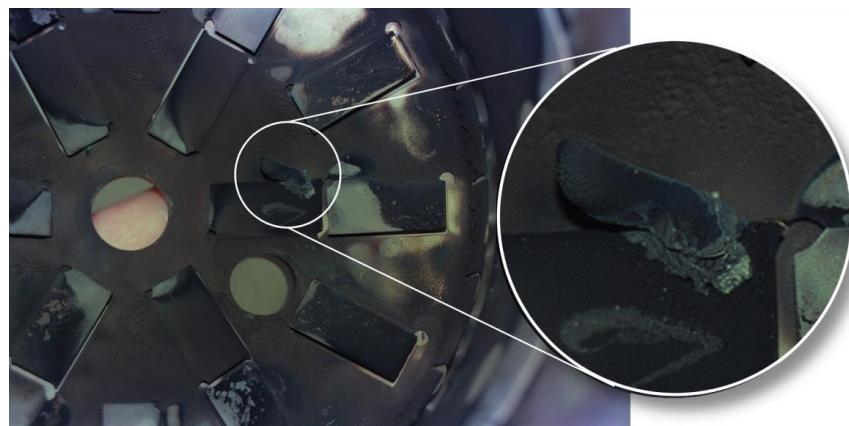
Figure 82. Enlarged View of Coke Deposition

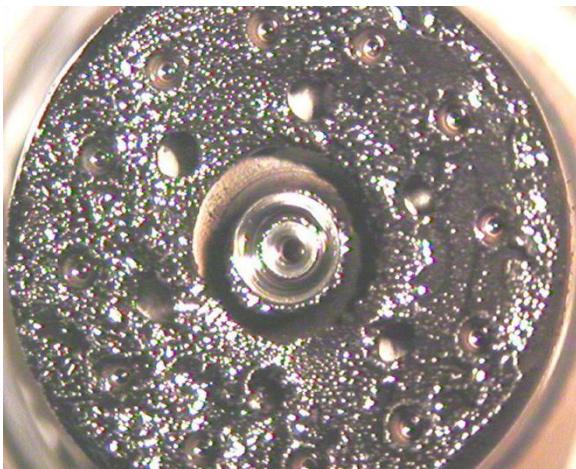
**Figure 83. Typical Coke Deposition
on Fuel Nozzle Face**

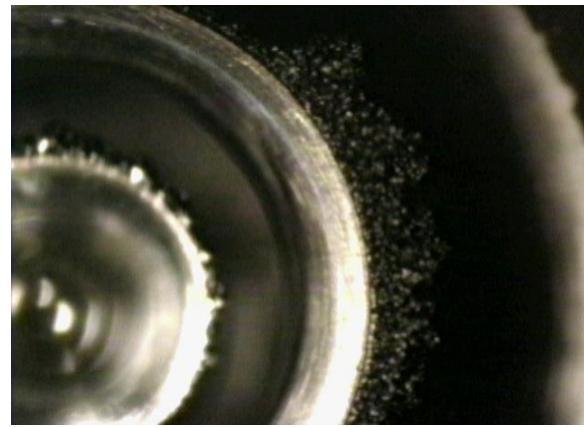
Figure 90. Enlarged View of Nozzle Coking

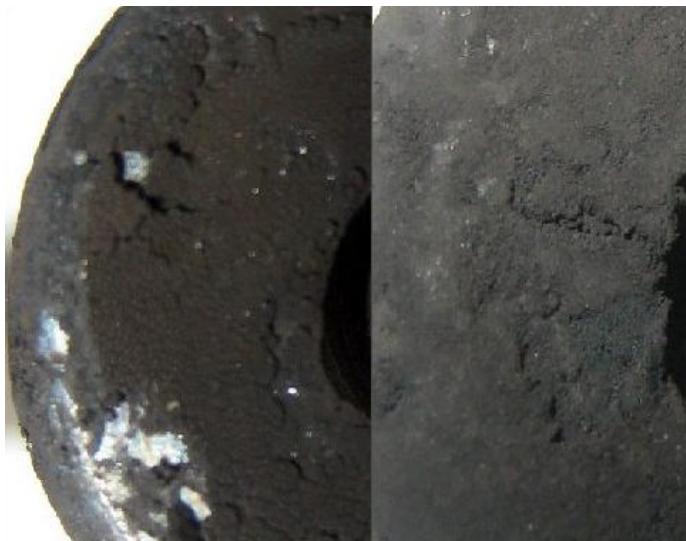
JP-8 use creates a very hard and tenacious layer of carbon deposits on the face of the J85 fuel spray nozzles as shown in **Figure L-4** that are difficult to remove. Similar coke deposits accumulate on the face of T56 fuel spray nozzles using JP-8 that are sometimes difficult to remove with a nylon brush during the yearly isochronal inspection of the C-130H aircraft that occurs at approximately 400 FH . In contrast, the carbon deposits on the J85 fuel spray nozzles that use JP-8+100 were much softer, powdery and very easy to remove. **Figures L-5 and L-6** show magnified images to highlight these differences. Note in **Figure L-5** that some of the carbon has already flaked off during handling of the nozzle. The difference in carbon deposits not only impacts ongoing base level maintenance workload but also refurbishment processes managed by the Depot and the procurement of spare parts. The fuel spray nozzles are cleaned and flow checked organically at the ERRC or by qualified subcontractors to determine if the part can Return To Service (RTS) or must be replaced with a new or refurbished fuel spray nozzle. Details of the impact on RTS and Not Reparable This Station (NRTS) rates for the various J-85 parts will be discussed later in this Appendix.

Figure L-5. Magnified Carbon Deposits From JP-8+100 Use

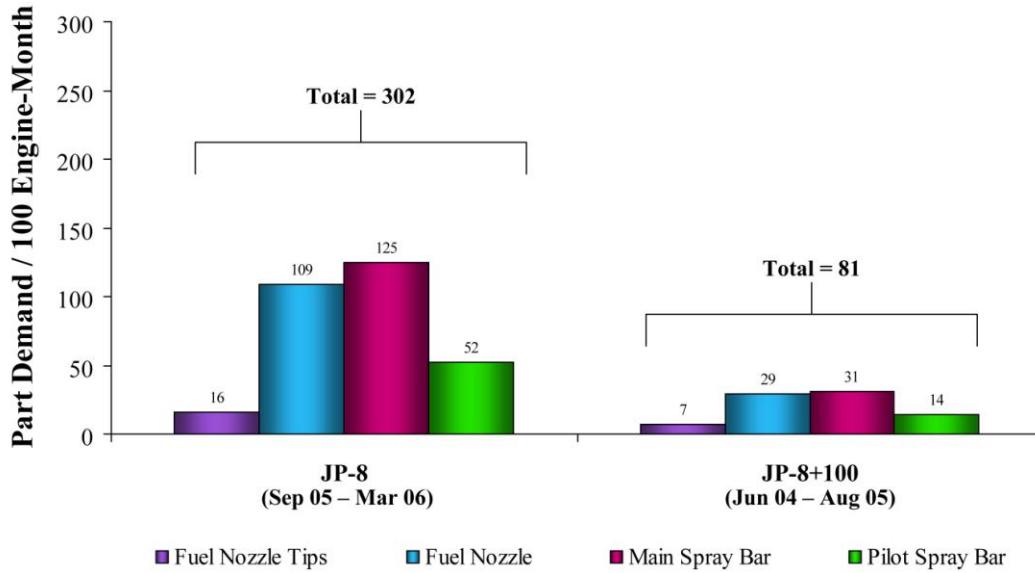
Figure L-11. J85 Parts Demand Comparison

During the 7-month period when JP-8 was used (September 2005 – March 2006), 57% of the engines shipped to the ERRC were for unscheduled maintenance compared to 52.2% during the 14-month period when using JP-8+100 (June 2004 – August 2005). When parts demand data was normalized on the basis of 100 engines per month a shown in **Figure L-11**, a more vivid comparison of the parts demand rates can be shown when JP-8 and JP-8+100 fuel was used. While the raw data shows nearly a 2X difference when JP-8 was used, the normalized data shows almost a 4X difference. This data also supports two comments made by Auxiliary Shop personnel at the ERRC after returning to JP-8 use:

- The maintenance workload increased to meet the fuel spray nozzle RTS demand rate which was also reflected in the number of fuel nozzle tips installed to obtain an acceptable spray pattern during flow bench testing.
- 100% of the pilot spray bars failed the flow bench test after using JP-8 compared to 50 to 60% of the spray bars passing the flow check when JP-8+100 was used.

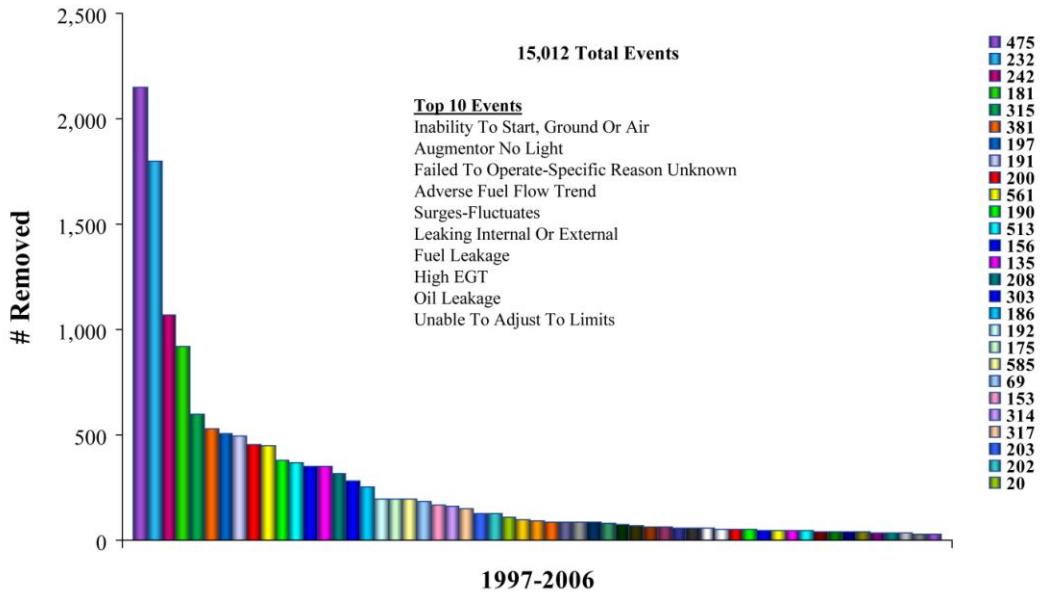
Figure L-12. J85 Unscheduled Engine Removals for all HMCs

Figure L-12 shows the unscheduled engine removals for 57 HMCs. A total of 15,012 engine removals were reported to the CEMS database during the Jan 97 – Sep 06 time period with the Top 10 events accounting for 60% of the total. Inability To Start (Ground or Air), Augmentor No-Light and Failed to Operate - Specific Reason Unknown were the top three causes for engine removals. The colored bars represent the total engine removals for all HMCs entered in the CEMS database although only 27 HMCs are listed on the Figure. The Top Ten Events are listed in descending order and correspond to the HMCs on the right of the Figure.

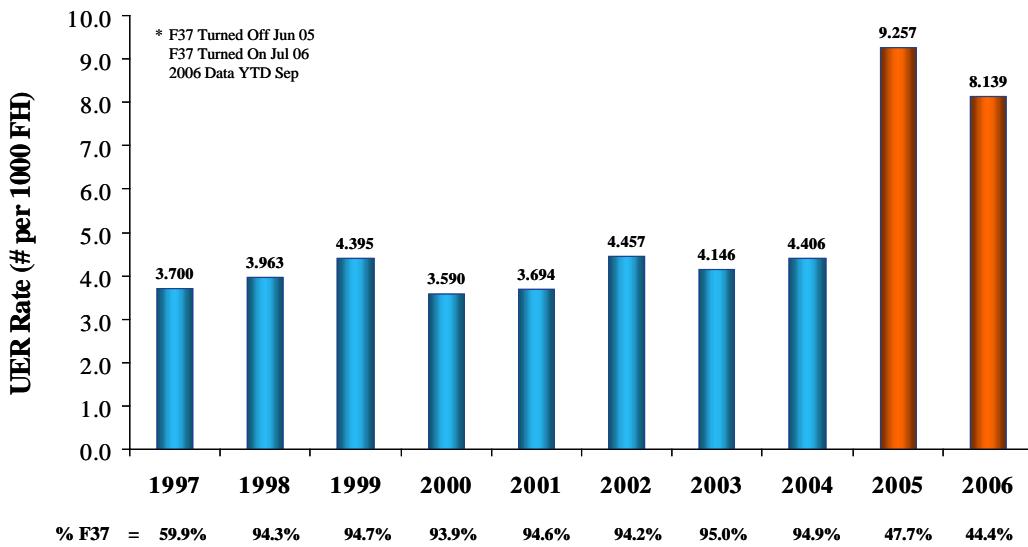
Figure L-13. J85 UER Rate for Top 10 Causes

Figure L-13 shows the yearly UER Rate for the Top 10 causes for engine removals from 1997 through 2004. Note that the UER Rate for the J85 fleet increased abruptly by 110% in 2005 when the +100 additive was turned off in June 2005 and decreased by 12% after the +100 additive was turned on in July 2006. The per cent (%) utilization of JP-8+100 (NATO F-37) is shown for each year. After conversion to the +100 additive in 1997, utilization averaged above 94%.

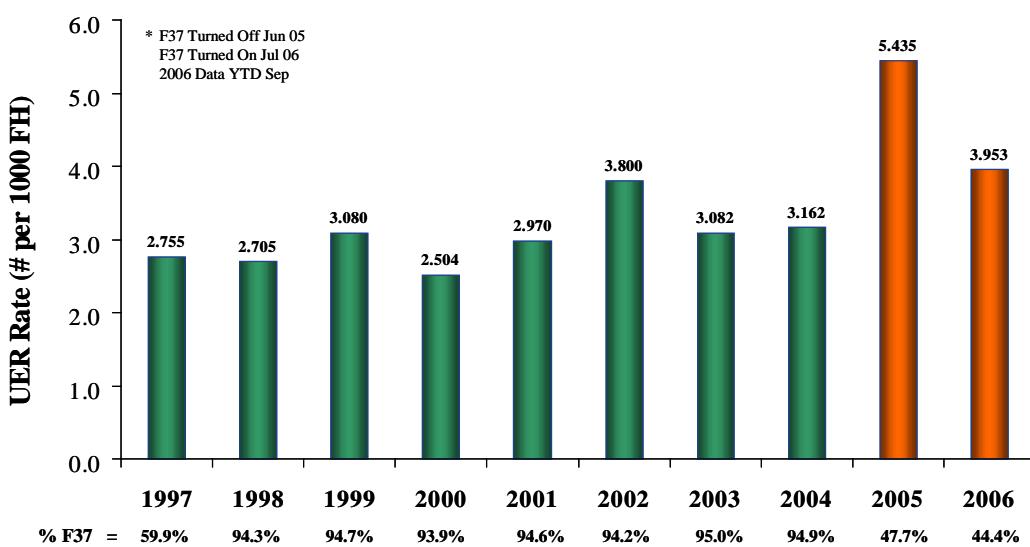
Figure L-14. J85 Afterburner Related Removal Rate Using HMC Subset

Figure L-14 shows the yearly J85 Afterburner Related Removal Rate using the HMC Subset shown in **Table L-2**. The fleet average UER Rate for afterburner removals increased by 72% in 2005 when the +100 additive was turned off compared to 99.7 % increase in UER Rate for the

J85 engine fleet using the same subset. The difference of 27.7% can be attributed to coking issues with the fuel spray nozzles and control components.

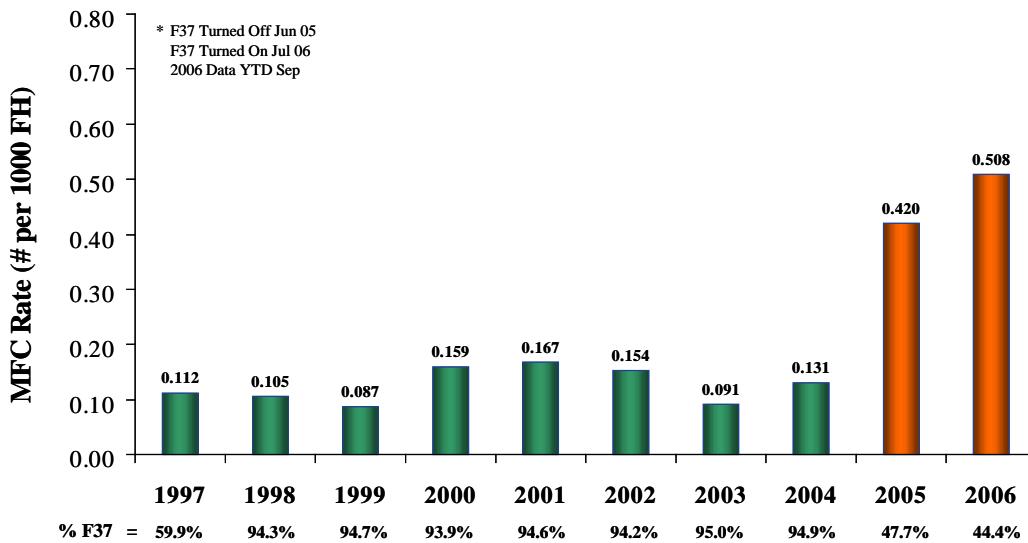
Figure L-15. J85 Afterburner Related MFC Removal Rate Using HMC Subset

Figure L-15 shows the yearly Afterburner Related MFC Removal Rate using the HMC Subset. The fleet average MFC Removal Rate related to afterburner events increased by 221% in 2005 after the +100 additive was turned off in June 2005 and then increased by 21% in 2006 even though the +100 additive was turned on in July 2006. This indicates the extent of maintenance that is performed to fix coking problems and clear engines for service. It is noteworthy that the MFC Removal Rate increased by 44% in 2005 for afterburner coded faults while the MFC Removal Rate increased by 84% for overall engine anomalies.

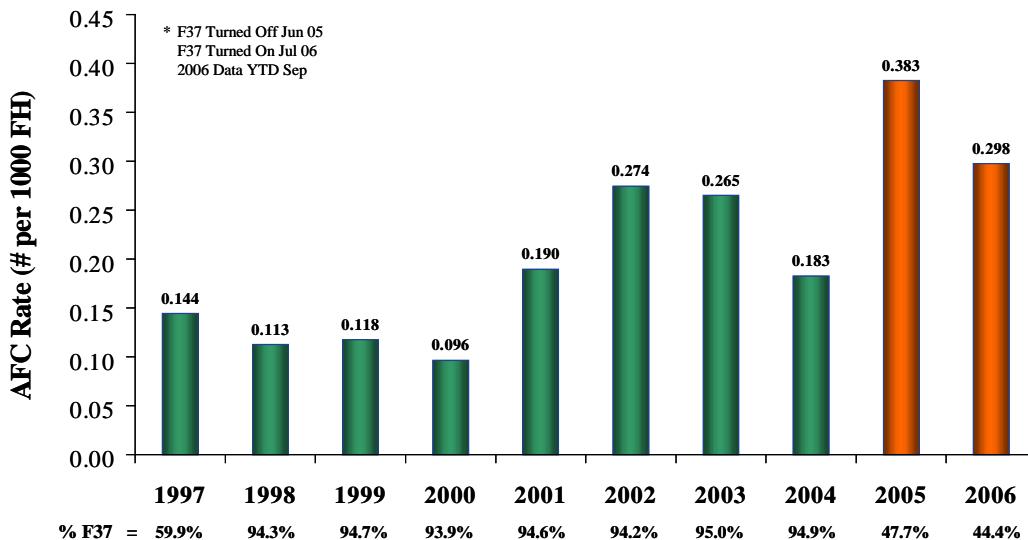
Figure L-16. J85 Afterburner Related AFC Removal Rate Using HMC Subset

Figure L-16 shows the yearly Afterburner Related AFC Removal Rate using the HMC Subset. The fleet average AFC Removal Rate related afterburner malfunction events increased by 109% in 2005 as a direct result of turning off the +100 additive. The 31% reduction in AFC removal rate in 2004 may be the result of replacing fouled or marginal AFCs during 2001 through 2003 that had caused afterburner anomalies. The 109% increase in AFC removal rate in 2005 may have contributed to the 33% decrease in the AFC removal rate in 2006 even though the additive was not turned on until July 2006.

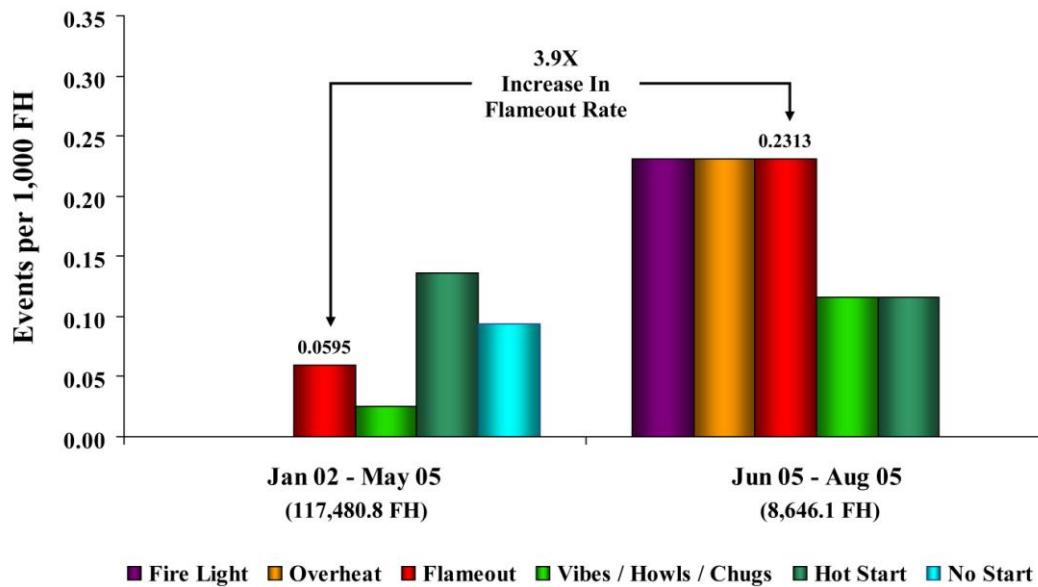
Figure L-17. Incident Rate of Potential Carbon-related Events Impacting J69

Like J85 engines, the J69 engines that power the T-37 are very sensitive to coking and experienced marked increases in engine anomalies after return to JP-8 use. Before direction was received to shut the +100 additive off in May 2005, Sheppard had been using JP-8+100 for over 10 years and had benefited from reductions in engine removals due to coking. Most notable was a 3.9X increase in the engine Flameout Rate after use of JP-8 resumed as shown in **Figure L-17**. However, problems in two other engine fault categories were indicated to include Fire Light and Overheat. During the 3½ years prior to May 2005, this training Unit had experienced a total of 37 coke related events but none related to fire light or overheat light indications. During the 3 months after the +100 additive was turned off in May 2005, the pilots reported 8 coking related events, four of which had not been experience since the mid to late 1990's.

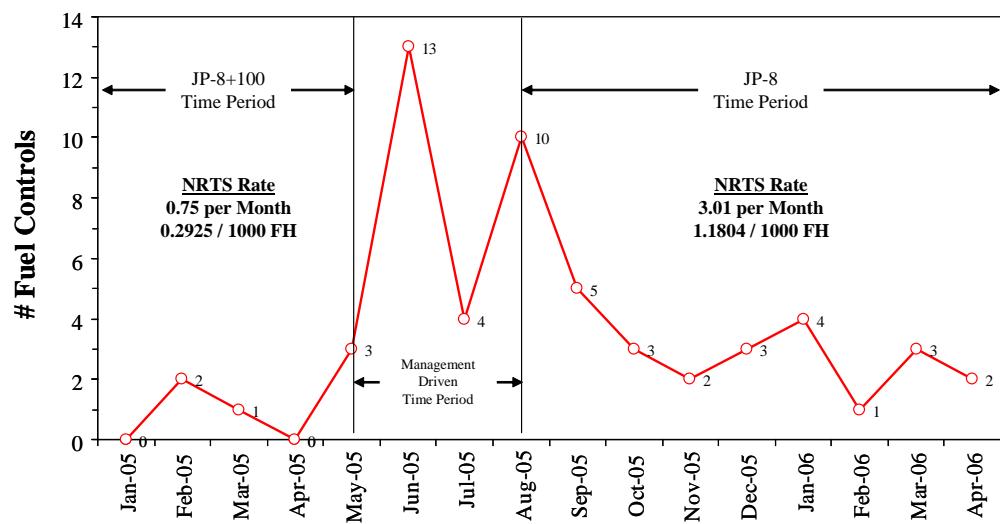
Figure L-19. J69 Main Fuel Control Removals

Figure L-19 shows the fuel control removals covering a 15 month period from January 2005 through March 2006. After the +100 additive was turned off in May 2005, 27 fuel controls were removed by management decision (Scheduled Maintenance) during a 3 month period.

Unfortunately, the reasons for the removals were not determined during the site visit but at that time media filters had been removed from the fuel trucks since media had been migrating into the aircraft and engine filters causing sticky valves in several fuel controls. Thus selected controls may have been removed as a precaution but could not be confirmed. Therefore, control removals have been divided into three time periods with appropriate observations noted. During steady state conditions from January 2005 through May 2005 while using JP-8+100, the average J69 MFC removals for the assigned aircraft were 0.75/month or 0.2925/1000 FH. During the transition period from mid May 2005 through mid August 2005 that included the conversion to JP-8 starting in May 2005, 27 MFC were removed during a 3 month period by management decision. During the following 8 month period from August 2005 through March 2006, the average MFC removals were 3.01/month or 1.18/1000 FH to fix engine anomalies caused by coking which is a 4X increase compared to the time period when JP-8+100 was used.

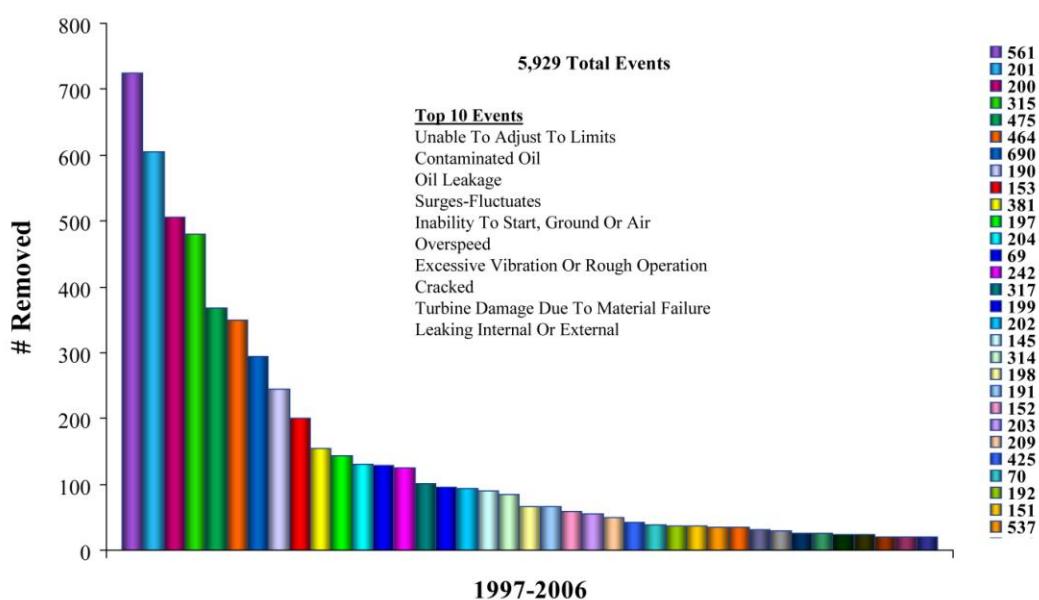
Figure L-20. J69 Unscheduled Engine Removals for All HMC

The unscheduled and management decision removal of engines and main fuel controls were analyzed for the majority of the J69 fleet from 1997 through September 2006. **Figure L-20** shows the number of the unscheduled engine removals that were documented in the CEMS database for all malfunctions. A total of 5,929 engine removal events were reported during the study period with the Top 10 events comprising 66% of the total. Using the HMC subset to determine potential fuel related removal events, **Figure L-21** shows 2,278 engine removals or 38% of all faults. The Top 10 events within the subset totaled 2,090 events or 92% of the total. The unscheduled engine removals using HMC 561 (Unable to Adjust to Limits) accounts for

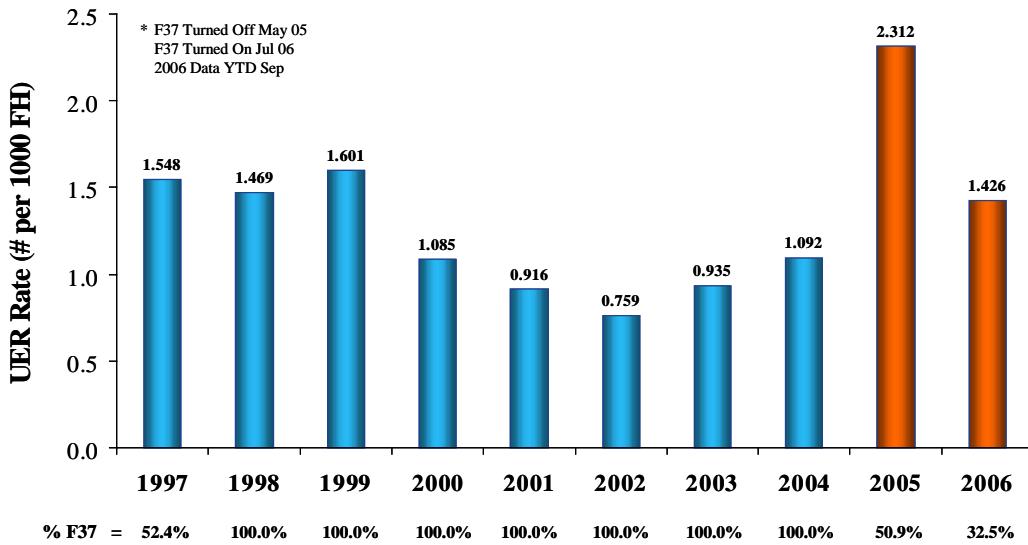
Figure L-22. J69 UER Rate for Top 10 Engine Removal Events

approximately 35% of the total while HMC 242 (Failed to Operate - Specific Reason Unknown) accounts for only 6%. After the +100 additive was turned off in May 2005 for 13 ½ months, the fleet average UER Rate abruptly increased by 112% in 2005 as shown in **Figure L-22**. The UER Rate had been declining starting in 2000, reached a new low in 2002 and then started a steady increase. Collective maintenance performed during 2005 reduced the UER Rate in 2006 by 38%.

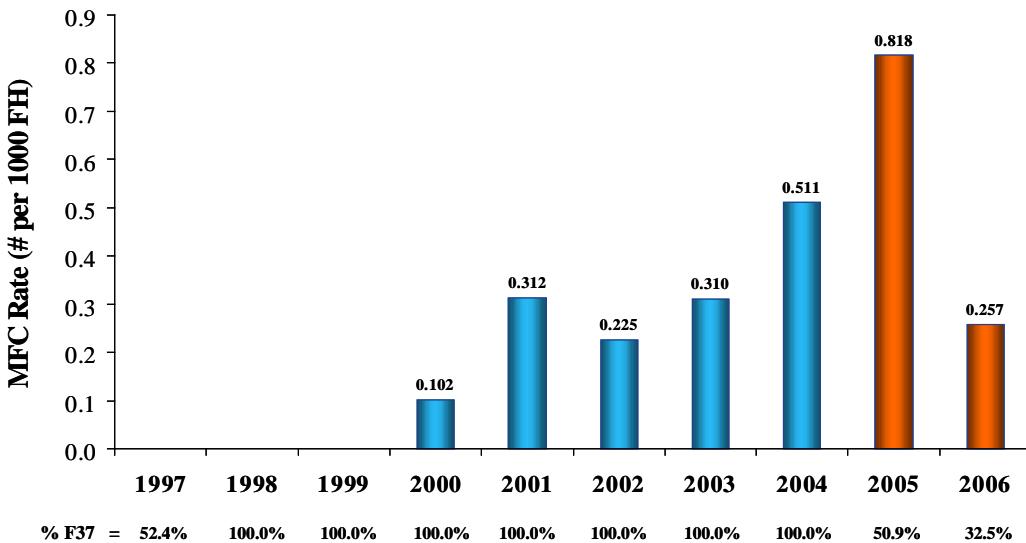
Figure L-23. J69 Unscheduled MFC Removal Rate for Top 10 HMCs

Figure L-23 shows the unscheduled MFC removal rate that increased by 60% in 2005 after the +100 additive was turned off in May 2005. The steady increase in the MFC removal rate starting in 2002 may be related to media migration from water-absorbing filters that caused sticking of valves in the MFC resulting in 38% increase during 2003 and a 65% increase in 2004. The 69% reduction in 2006 may be due to the increased number of MFC that were changed during 2004 and 2005 to deal with valve sticking problems and a partial year when the +100 additive was turned on in July 2006. The management driven MFC removals during the May to August 2005 time period helped purge some MFC with sticking valve problems plus the water-absorbing filter monitors were removed from refueling trucks and replaced with filter coalescers.

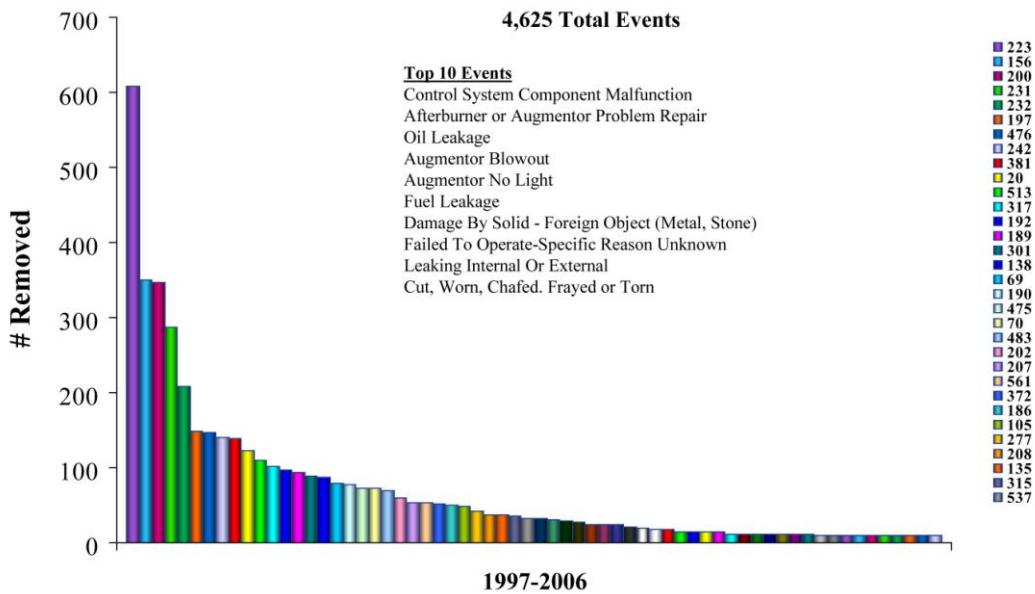
Figure M-1. F100-100 Unscheduled Engine Removals – All HMC

The unscheduled removal of -100 engines and the Unified Fuel Control (UFC) were obtained from the CEMS data base for the time period from CY97 through September 2006. **Figure M-1** shows the distribution of -100 unscheduled engine removals for all malfunctions. A total of 4,625 removals were recorded during this time period with the Top 10 events comprising 54% of the total. Note that Control System Component Malfunctions, Augmentor Blowout and No-Lights are in the top five most frequent causes for removals with Failed to Operate-Specific Reason Unknown ranked eighth. The synergies of the RCM program initiated in 1997, the baking and cleaning program, evolving engine shop procedures and use of JP-8+100 provided

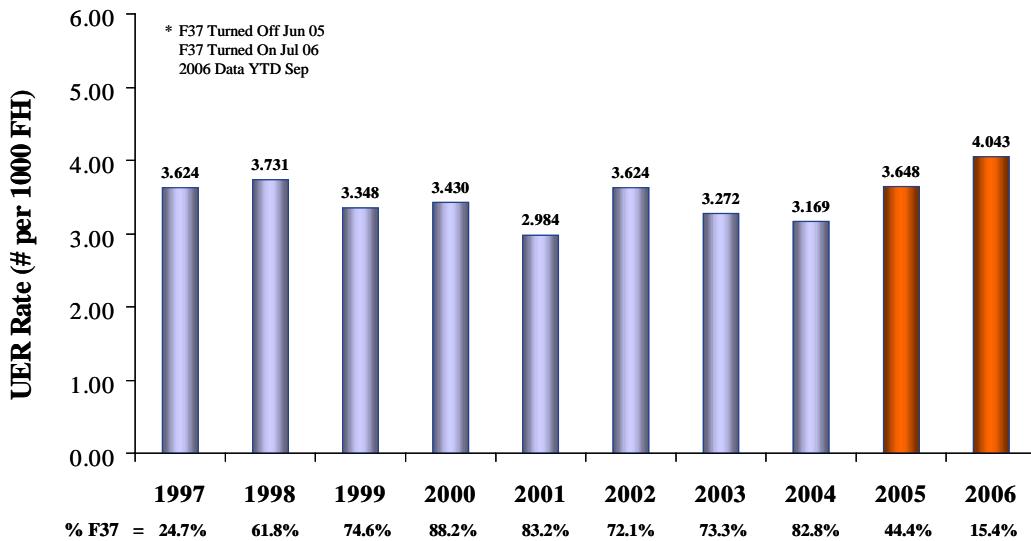
Figure M-2. F100-100 UER Rate Trend for Operational & Gas Path Deterioration

fairly stable conditions to minimize year to year changes in the UER Rate shown in **Figure M-2**. While the number of events declined in 2005, the fleet average UER Rate increased by 15% after the +100 additive was turned off in June 2005 due to fewer flying hours for the F100-100 fleet in 2005 and 2006. **Figure M-3** shows a decline in the Unscheduled Augmentor Removal Rate starting in CY97 but a 26% increase is noted in 2005 and a 33% increase in 2006 compared to 2004 after the +100 additive was turned off but the metric was influenced by fewer flight hours for the -100 engine fleet.

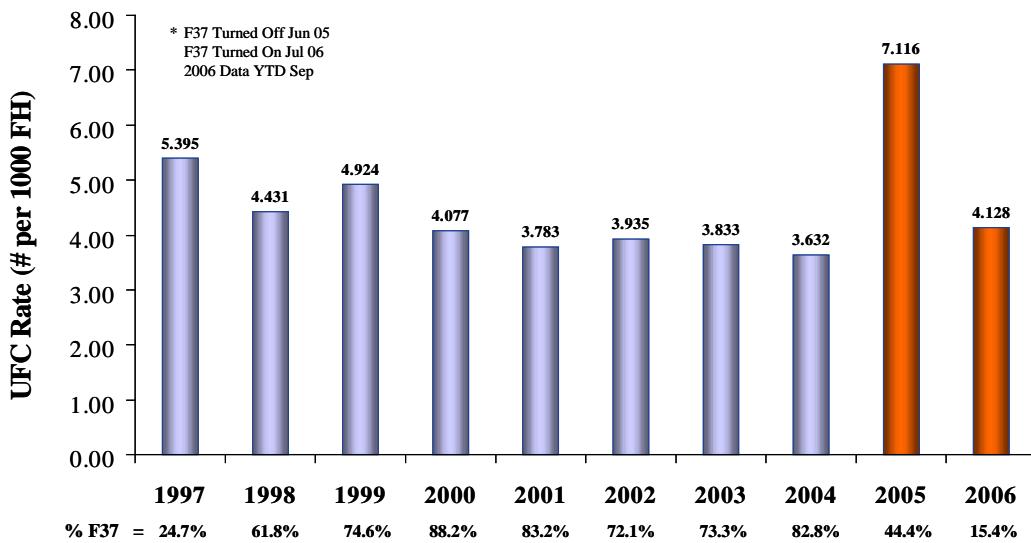
Figure M-4. F100-100 UFC Removal Rate for Operational & Gas Path Deterioration

The F100-100 uses a Unified Fuel Control (UFC) and EEC to regulate the engine variables, augmentor and exhaust nozzle. The UFC is a back to back MFC and AFC that was combined to save engine weight but is removed more frequently to fix engine anomalies. The largest number of UFC removals was recorded using HMC 223 and the second largest HMC 242. HMC 561 removals were ranked fourth. HMC 242 is frequently used when in doubt of the cause of a malfunction. **Figure M-4** shows a steady decline in UFC Removal Rate for Operational and Gas Path Deterioration but the unscheduled removal rate increased 96% in 2005 when the +100 additive was turned off in June 2005 for 12-13 months. Replacing marginal controls in 2005 and performing engine trims provided a significant reduction of UFC Removal Rate in 2006.

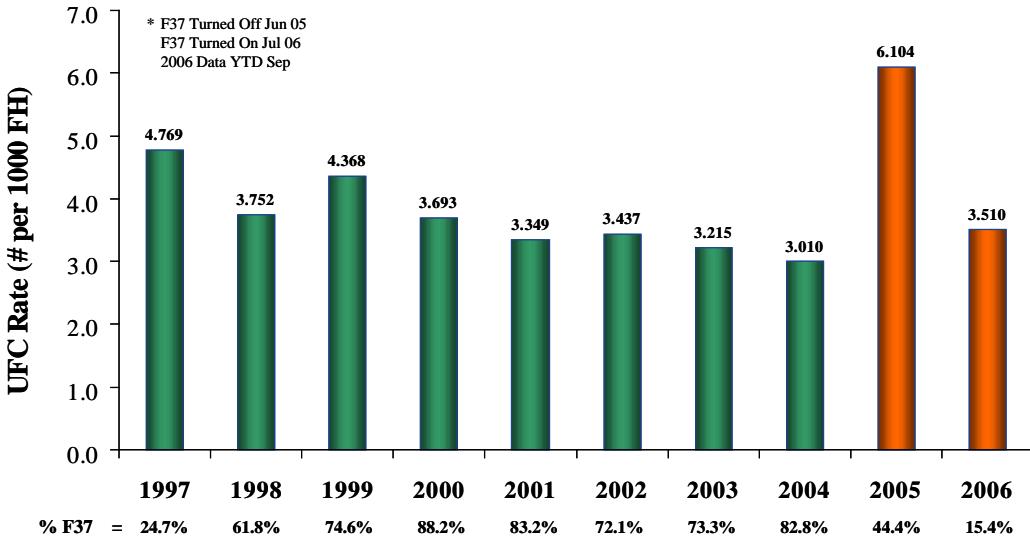
Figure M-5. F100-100 Augmentor Related UFC Removal Rate Using HMC Subset

Figure M-5 shows the UFC Unscheduled Removal Rate for augmentor related malfunctions. Note that the fleet average UFC Removal Rate increased by 103% in 2005 when the +100 additive was turned off and decreased by 42% in 2006 from the marginal controls that were replaced and the engine trims that were performed.

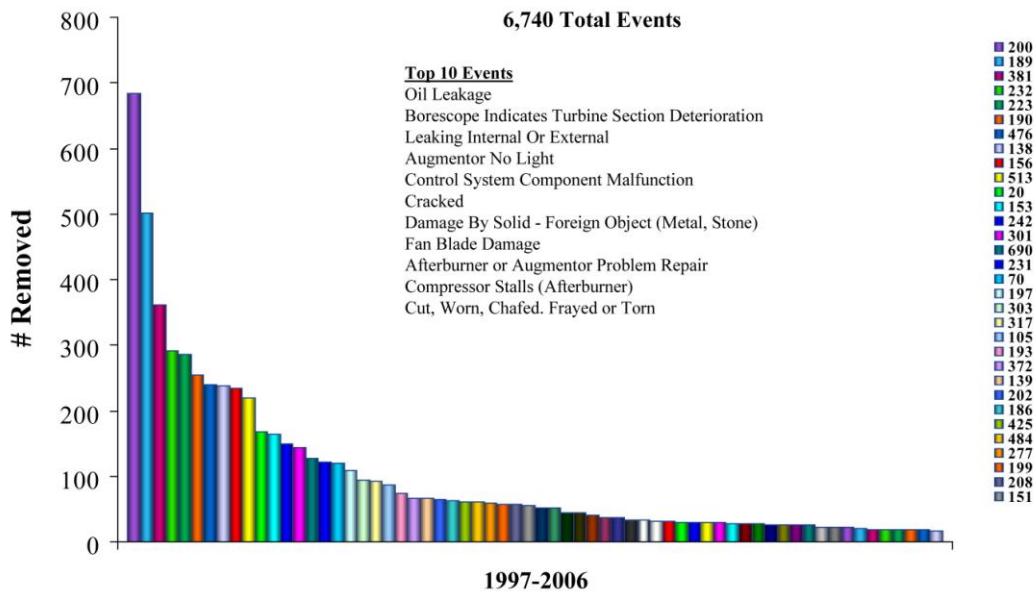
Figure M-6. F100-220/E Fleet Unscheduled Engine Removals for All Faults

Figure M-6 shows the number of Unscheduled Engine Removals for all malfunctions. A total of 6,724 events were recorded from January 1997 to September 2006. Top 10 events make up 49% of the total. The Top 5 are Oil Leakage, Internal and External Leakage, Turbine Section Distress, Augmentor No-Lights and Control Malfunctions. The unscheduled removal of the main fuel controls and augmentor fuel controls were also analyzed to determine the impact of the evolving maintenance practices to deal with coking and the use of JP-8+100. The steady decline in the UER Rate for the engine fleet shown in **Figure M-7** from 1997 through 2006 is a direct result of the RCM Program that helped improve the reliability of the gas path hardware, the evolving maintenance procedures and the use of JP-8+100. As a result, the gas paths of the engines were approaching more sustainable levels of reliability. When the additive was turned off in June 2005, the Fleet Augmentor UER Rate increased by 20% through the end of 2005 and increased by an additional 5% through September 2006 as shown in **Figure M-8** indicating that coking from JP-8 use had an impact on engine anomalies such as augmentor no light. With improved gas path reliability, the Unscheduled Removal Rate of MFCs experienced a steady decline as shown in **Figure M-9** and had reached a sustainable level starting in 2001 but increased by 52% when the +100 additive was turned off. The top two reasons reported for MFC removals were Control System Component Malfunction (HMC 223) and Failed to Operate-Specific Reason Unknown (HMC 242). HMC 242 is used when the flight line mechanics are unable to fix an engine anomaly and need to remove the engine for further investigation by the engine shop. **Figure M-10** shows the distribution and frequency of events for the malfunction codes that were reported in CEMS for F100-220/E AFC removals from 1997 through July 2006. The Top 10 events represent 75% of the total. The top event, Dirty Contaminated or Saturated by Foreign Material (HMC 230), reports the AFCs that were removed to clean the coke particles and gums that had accumulated in the outlet ports of the fuel manifold. The coking contributed to the Augmentor No Light, Control System Component Malfunction, Failed to Operation-

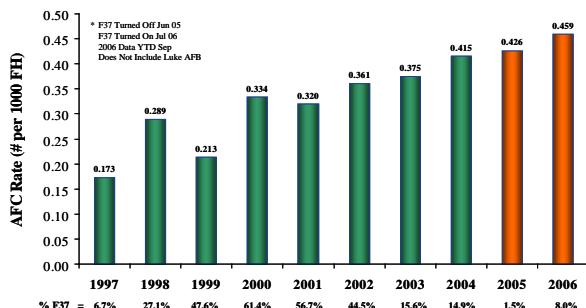
Figure M-11. F100-220/E Augmentor Related AFC Rmvl Rate in F-16C/D for HMC Subset

Specific Reason Unknown and the Augmentor Blowout events that forced removal of an AFC. **Figure M-11** shows the trends for the fleet Augmentor Related AFC Removal Rate. The steady increase in AFC Removal Rate starting in 1997 is due to coking in the fuel manifold outlet ports. Seg III has the most accumulation. Local shop procedures have been developed to remove the gums and coke particles and return the AFC to service. **Figure M-12** shows the fleet AFC Removal Rate caused by carbon/coking related fault codes. As JP-8+100 use decreased from 61.4% in 2000 to 14.9% in 2004, the AFC removal rate increased 33% from 0.215 events/1000 FH in 2000 to 0.286 in 2004 and 2005. If the carbon/coke related events were removed from **Figure M-11**, the AFC Removals remained nearly constant starting in 2000 through 2005 indicating that Units were staying on top of the AFC coking problems. When the +100 additive was turned off in June 2005, the fleet AFC Removal Rate increased by 3% in 2005 and 8% in 2006. When JP-8+100 use at one Unit decreased from 100% to less than 50% utilization in 2003, the UER Rate increased by 74% during the following year and an additional 24% increase in 2005 when the +100 additive was turned off in June 2005 providing a clear indication of engine sensitivity to the percent utilization of JP-8+100 in the -220/E engines.
